INDEPENDENT ROOF INSPECTION SERVICES

ROOF INSPECTION REPORT

HEATH STREET EAST.
TORONTO ONTARIO.

APRIL 11 2026

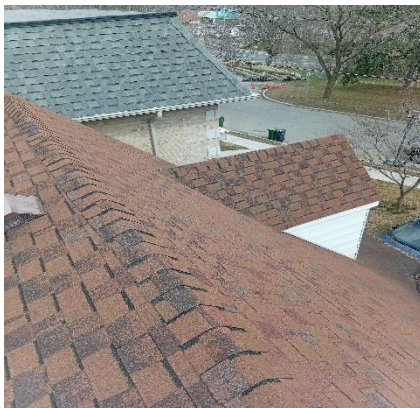
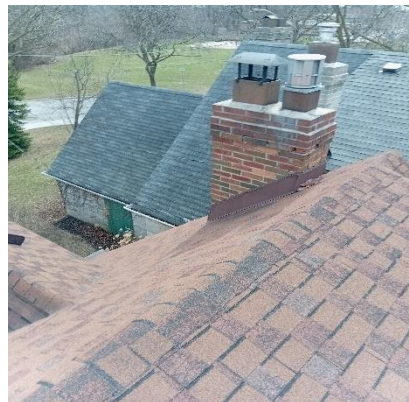
Image 001 shows the chimney with active exhaust vent piping. 001

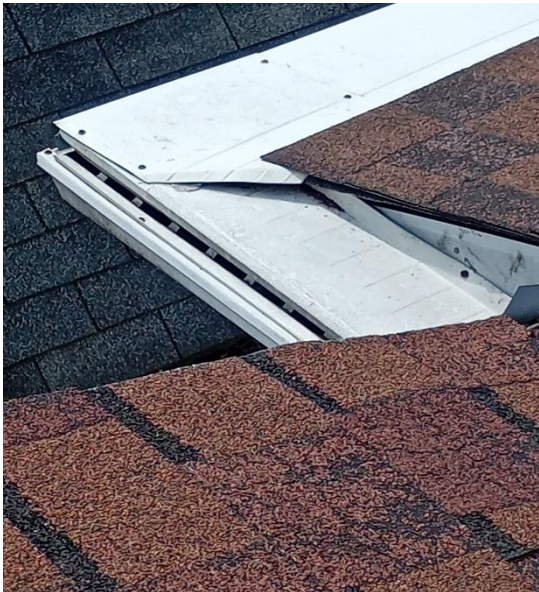
We conclude that the main and extension shingles do not allow for water ingress, however, the perimeter detail of the extension roof incorporates a sheet metal 'flashing' set beneath the bottom row of shingles that conceals the eavestrough. This circumstance will cause water to overflow the eavestrough and during ice and snow build up, allow water to enter the soffit detail and into the structure. See images on the following page.

Cont/ Images 002 and 003 Sheet metal concealing the eavestrough. Improper drainage. 3
Removal of the metal to expose the trough and prevent water overflow to the Mud Room roof below and leaks at other locations would be complex and expensive.

- 1) IMAGES ON PAGE 3. SHEET METAL AT BOTTOM EDGE CONCEALING THE EAVESTROUGH. Removal of the sheet metal and necessary shingle work to allow for better drainage would be difficult roofing wise and quite expensive.
- 2) Images 004, 005, 006. Mud Room. The damaged shingles could be replaced. The eaves trough and leaf guard could be repaired.

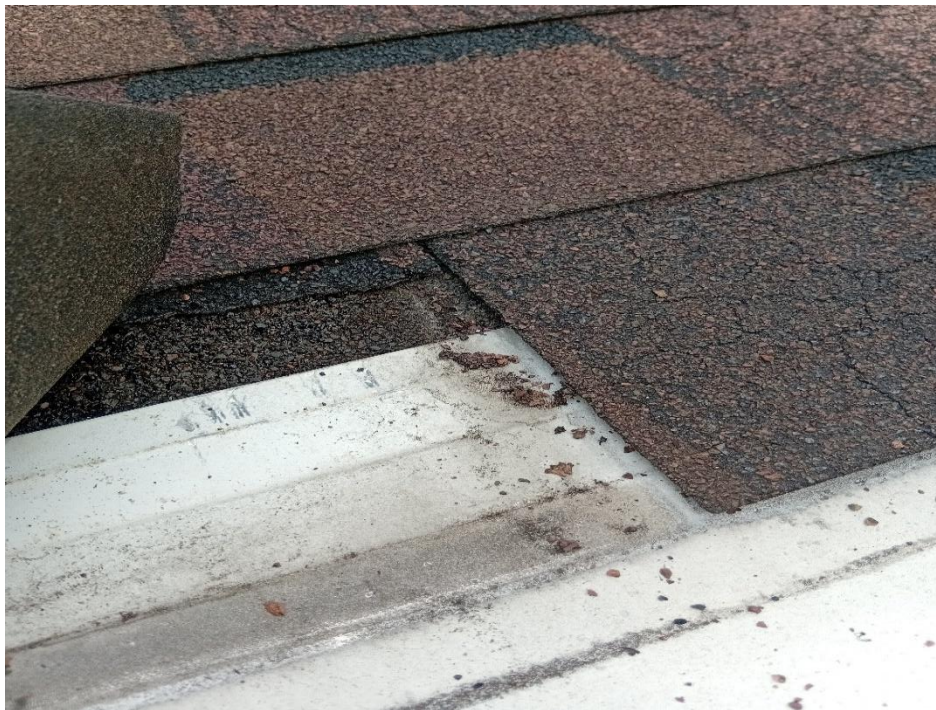
Sheet metal 'flashing' set beneath the bottom shingle row of shingles. Possible source of leaks when ice dams build up.

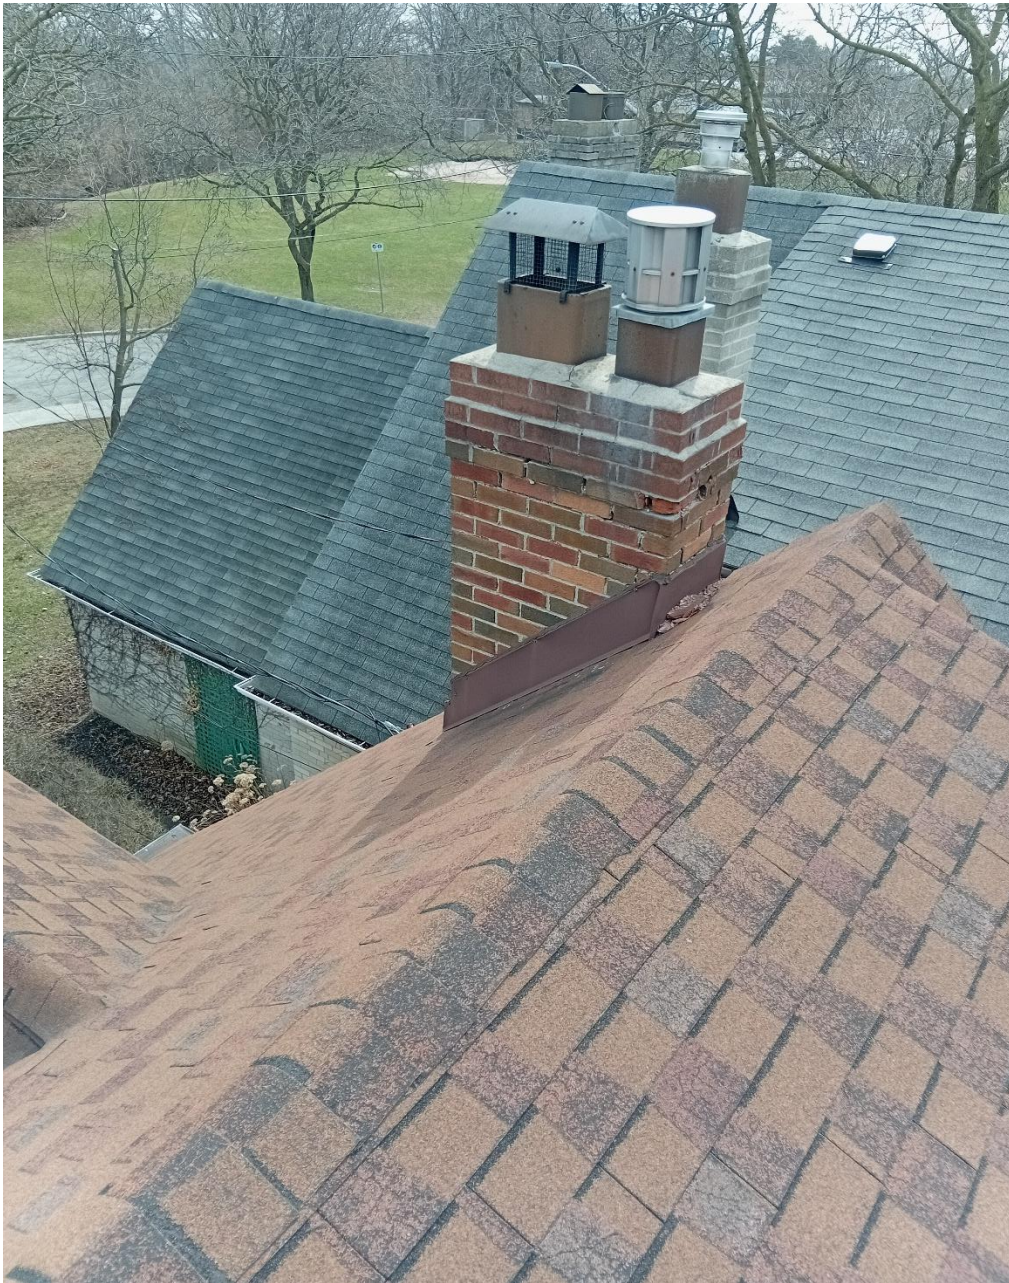
- 1) Active and on the original roof structure, we feel that repairs will allow this chimney to survive for the foreseeable future. Note the darker areas where granules have worn off.

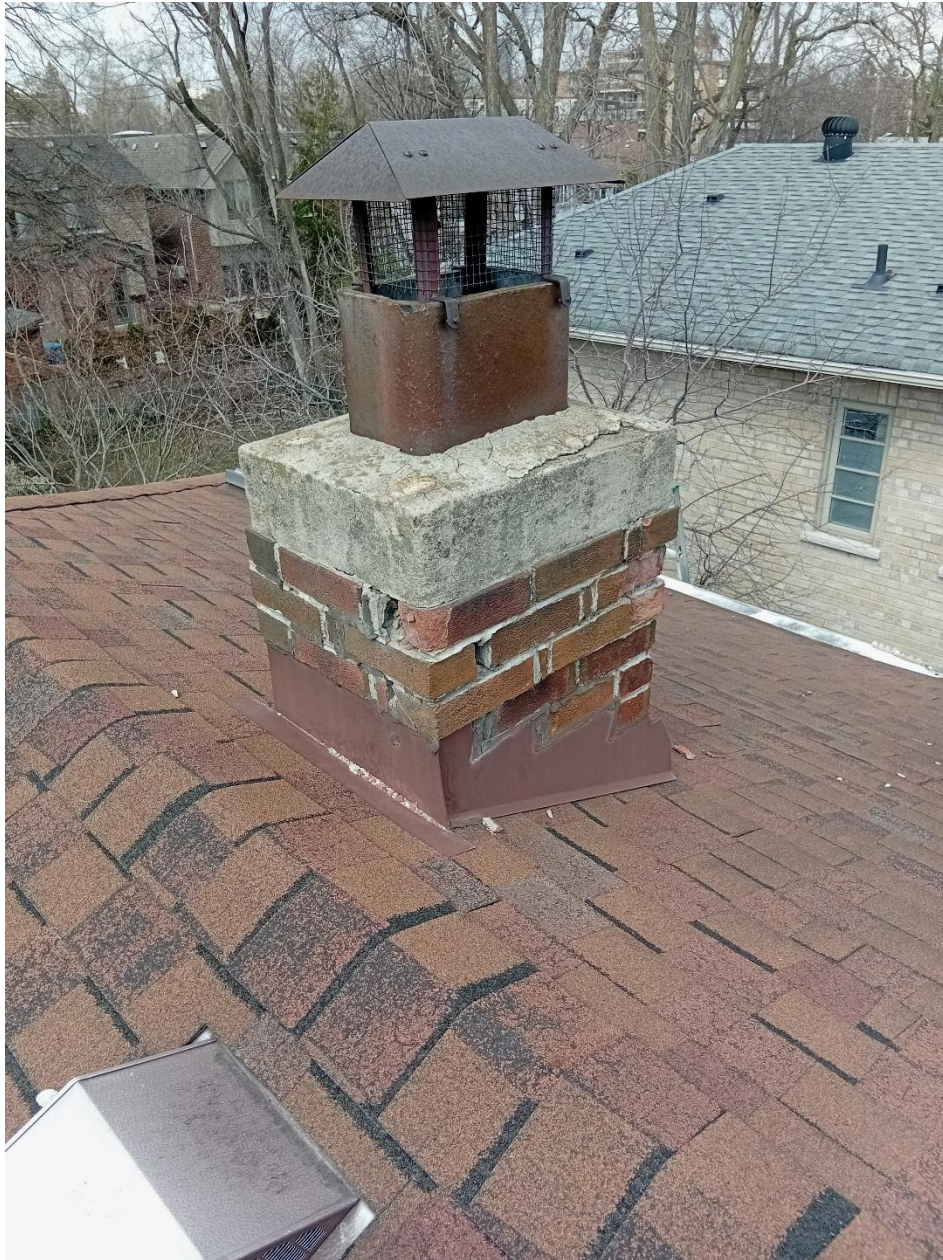
- 2) Rear extension redundant chimney. Clearly in need of attention but likely repairable. We do not feel that complete removal is necessary at this time. However, if the shingles were to be replaced, it should be demolished down to roof level.

- 1) The shingle roofing should remain serviceable for five more years.
- 2) Ice dams appear to be the cause of water ingress notwithstanding the details shown in Page 3 images. Perimeter heating cables strategically placed might suffice here.
- 3) Given the expense involved in remediation, heat cable installation and the short life span of the existing shingles it might be prudent to replace the roofing at this time
- 4) Demolition and re-building of the active chimney should not be necessary; repairs will suffice.
- 5) The rear chimney should be demolished if the existing roofing is replaced, otherwise just repaired.

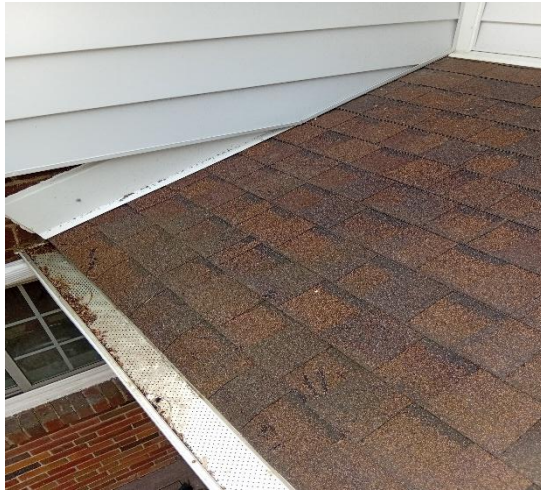
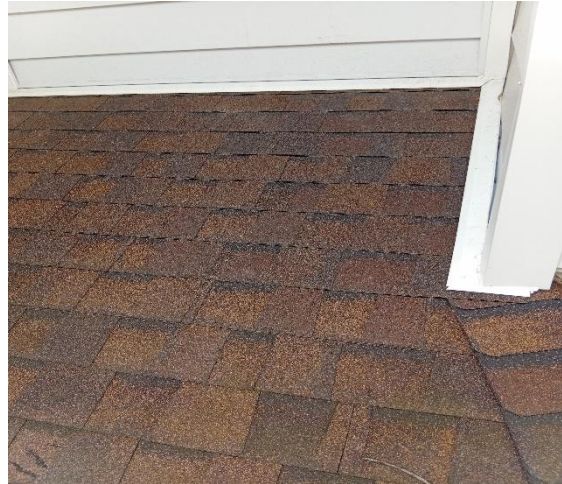
Overviews.

Water ingress is reported in the room below when ice dams build up. Any ice dam build-up will be exacerbated by water overflow from above. Except for two minor deficiencies the shingles are sound and will shed water properly. They could be replaced with an underlay sufficient to prevent said ingress when ice dams occur, but we feel that the installation of heating cables will suffice until complete re-roofing of the property is initiated.

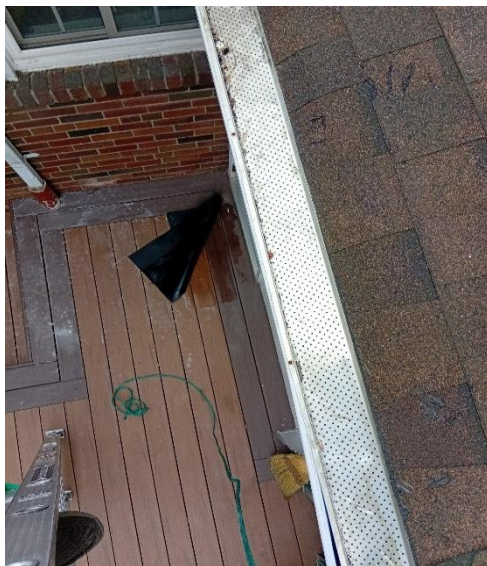
004

Minor deficiencies. All due to ice dam removal.

Image 004. Minor damage to 'ridge' cap shingles.

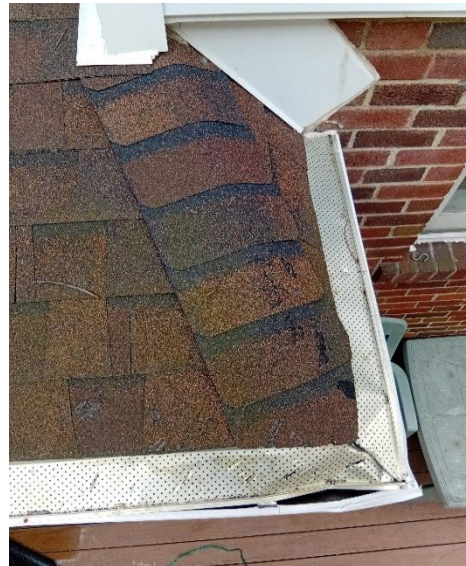
005

Image 005. Minor damage to lower edge material.

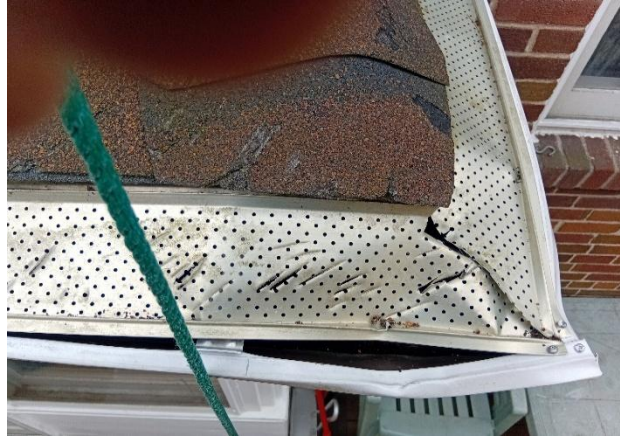
006

Image 006. Damage to shingles, eavestrough and leaf guard due to ice dam removal.
