INDEPENDENT ROOF INSPECTION SERVICES

ROOF AND ATTIC INSPECTION REPORT

ST. ANDREWS GARDENS
TORONTO ONTARIO.

NOVEMBER 26 2025

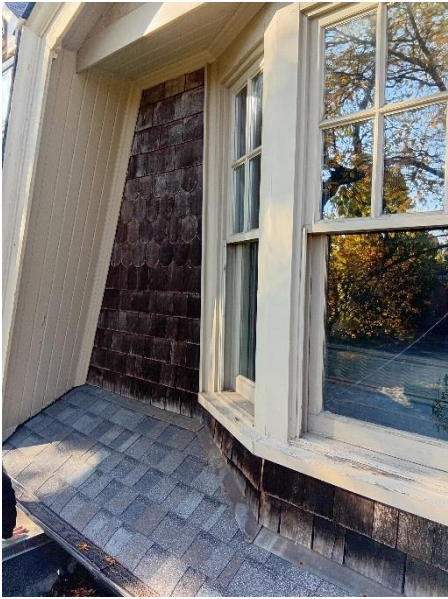
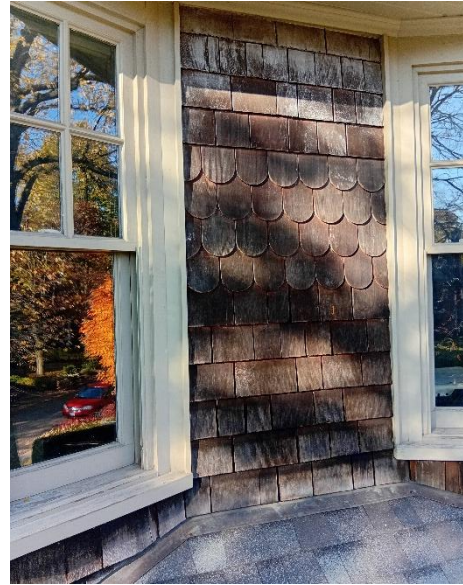
North exposure (front) lower veranda fiberglass shingles, cedar Mansard and small flat roof. Except for the deficiency (Image 001) everything here should remain serviceable for at least five years

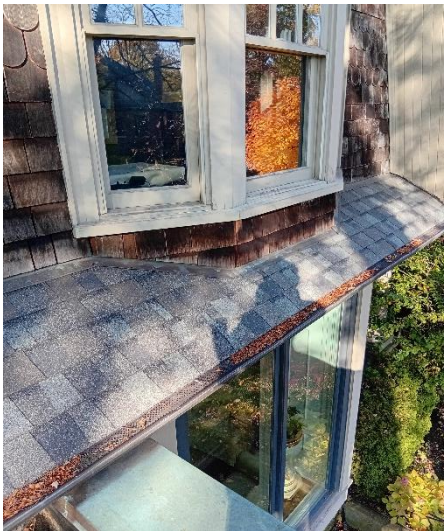
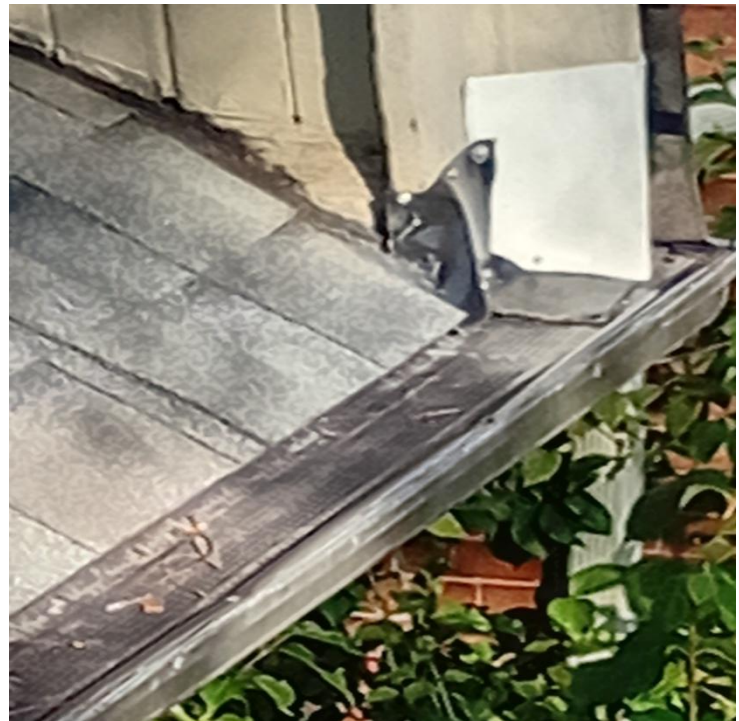
001

Image 001. Deficiency. Caulking of shingle end at wood siding and sheet metal piece need to be caulked.

IN THAT REGARD WE HIGHLY RECOMMEND THE SERVICES OF DOMINION SHEET METAL AND ROOFING WHO OFFER WHAT IS KNOWN IN THE TRADE AS A 'ROOF TUNE UP'

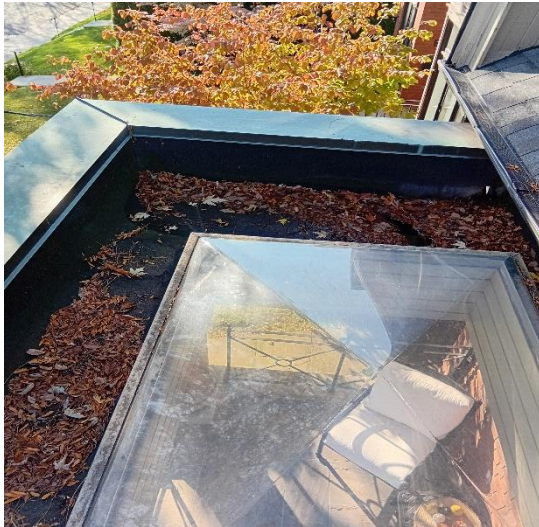
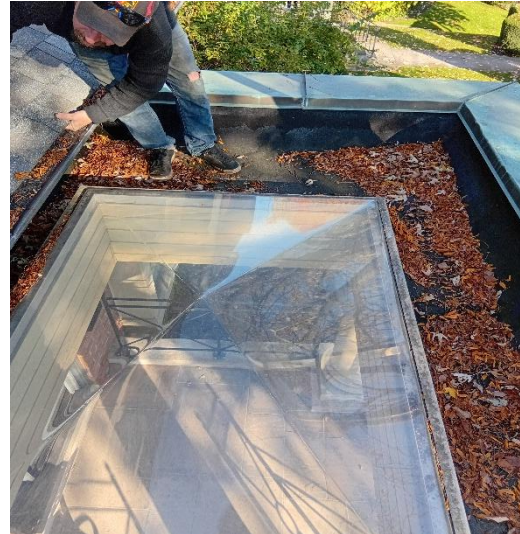
Cont/
PORCH FLAT ROOF.

Waterproofed with a two-ply modified bitumen membrane and associated copper flashings, serviceable for at least five years. No leaks are reported. The skylight is sound.

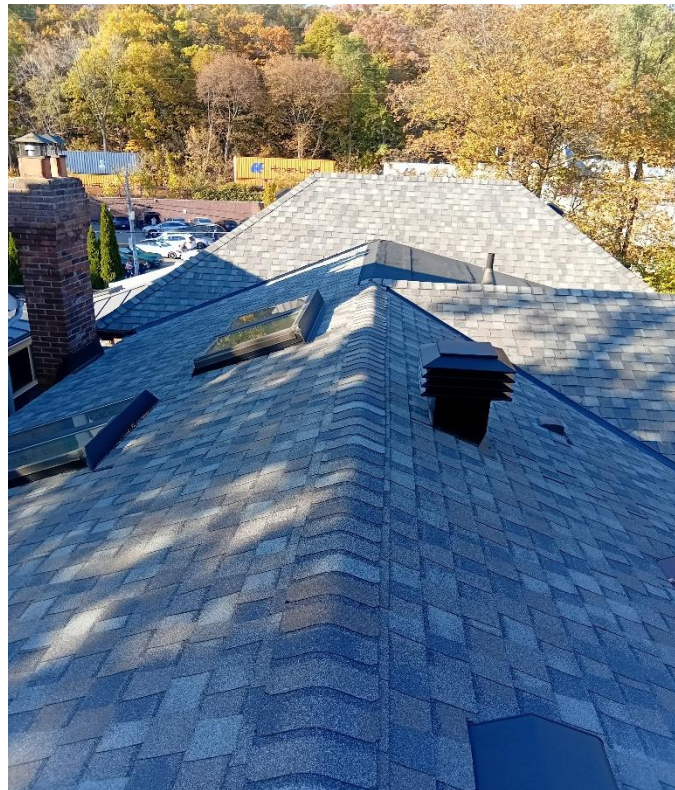
OVERVIEW MAIN SHINGLE ROOF.

Except for any deficiencies listed herein, all systems should remain serviceable for at least five years.

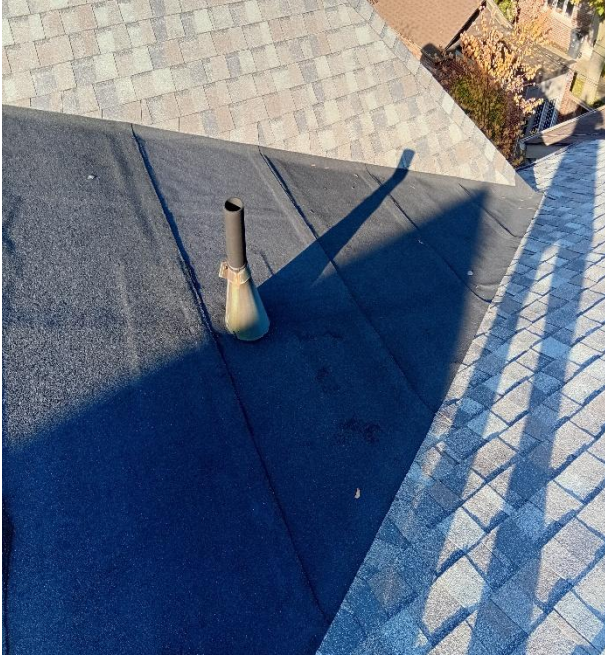
002

Cont/
Images 002and 003. Small flat roof. Upper main roof.

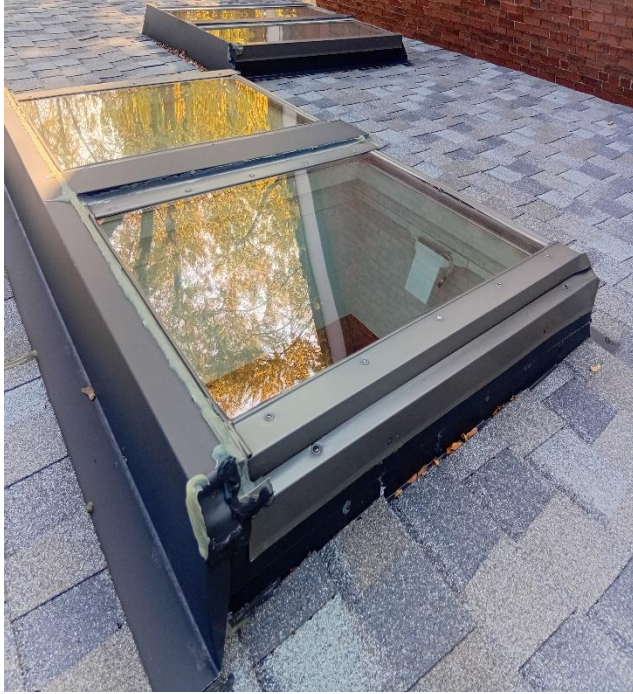
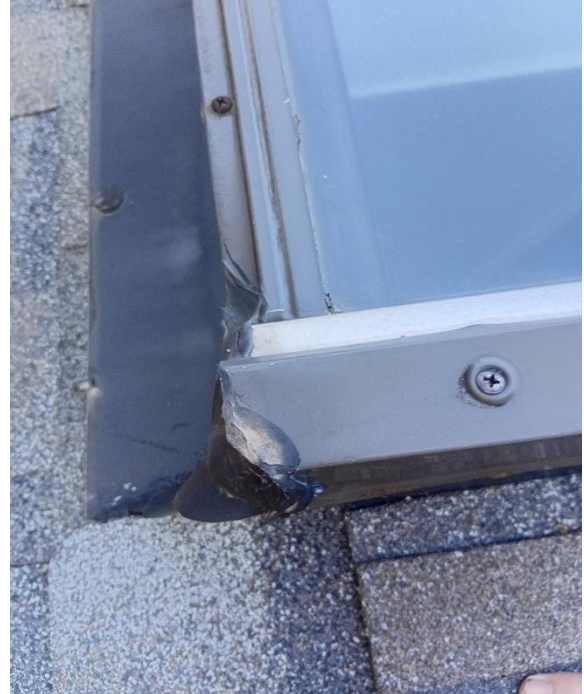
- 1) Caulked seams of the sheet metal framing. East exposure

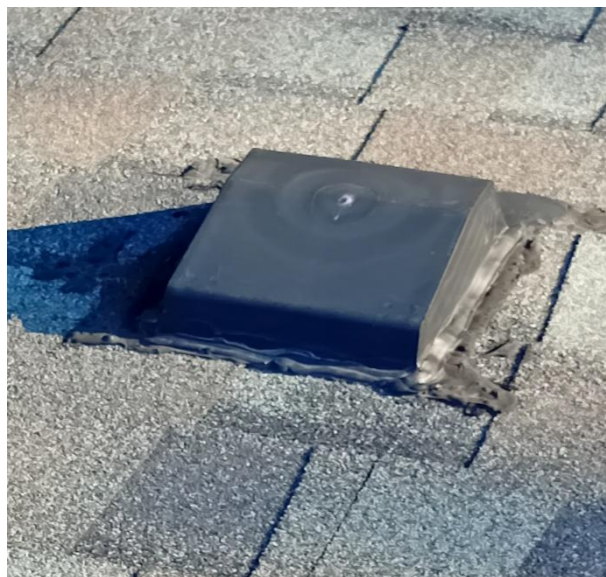
003

- 2) Image 003. Previously caulked exhaust air fitting main roof. This should be replaced.

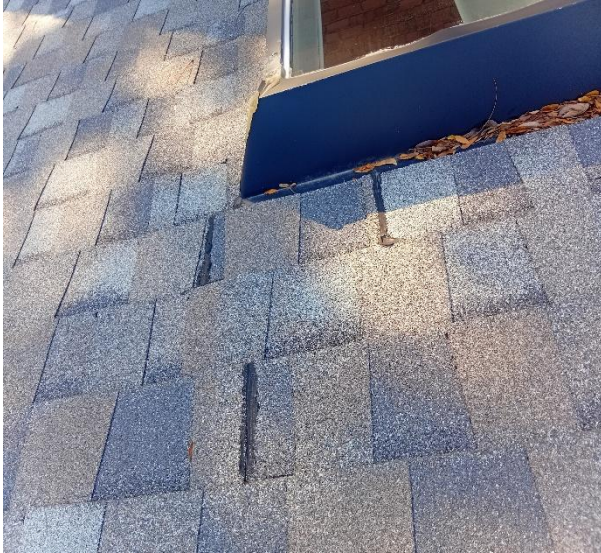
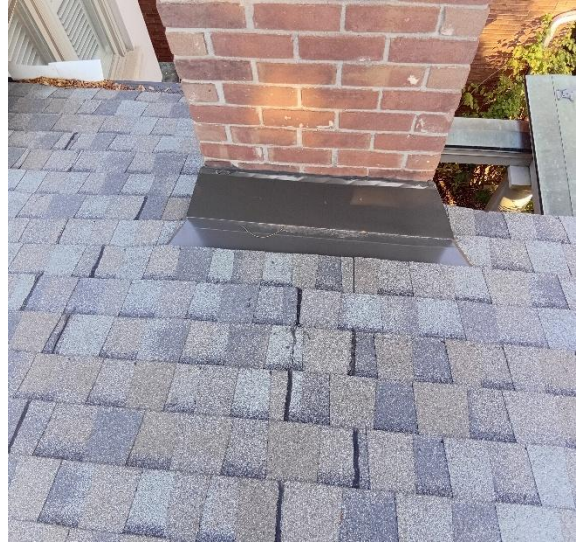
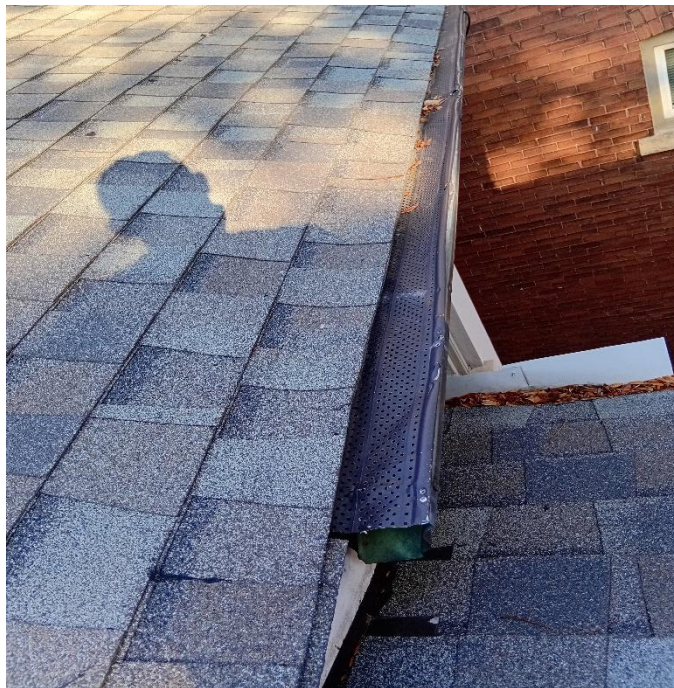
There is evidence of minor leakage in three locations which appeared during last years cold winter when ice and snow build up was extreme, which, as reported, were not currently active

3) Caulked shingle tabs. Various locations. These suggest that leaks had occurred.

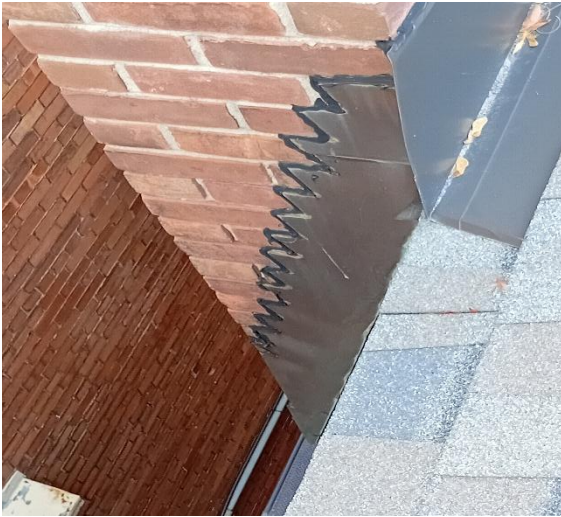
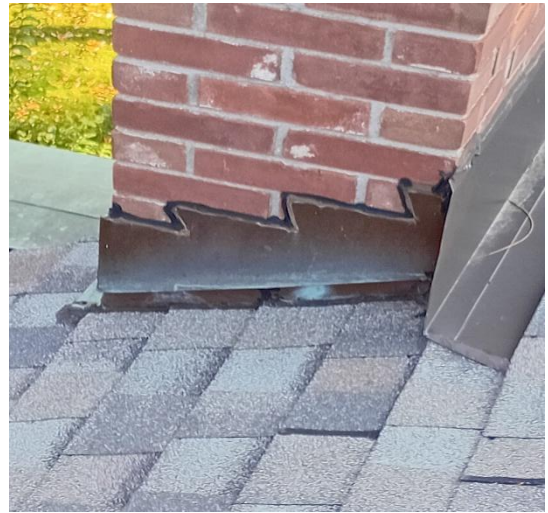
Cont/
CHIMNEYS.

Generally sound. Some caulking required.

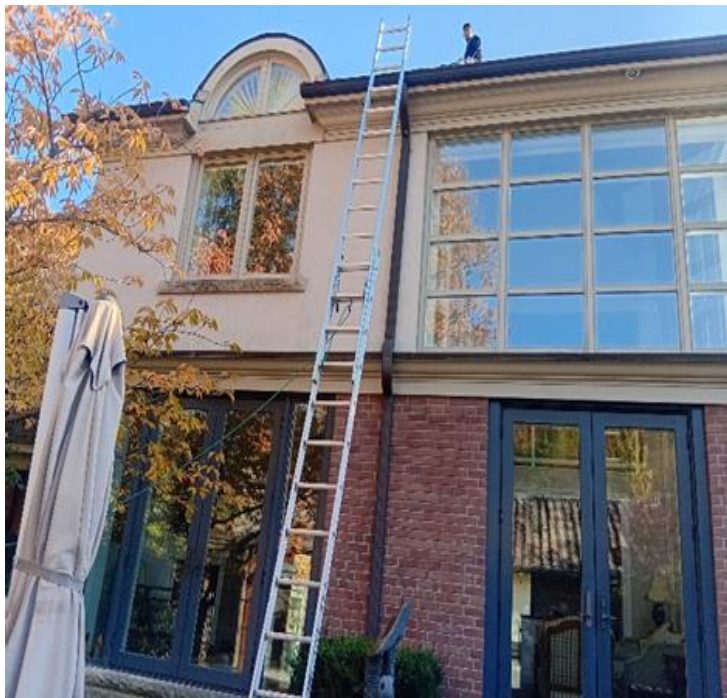
REAR EXPOSURE. EYEBROW WINDOW DEFICIENCY.

Below the window the stucco is cracked. This suggests that water is penetrating the corner of the eyebrow or the adjacent sheet metal.

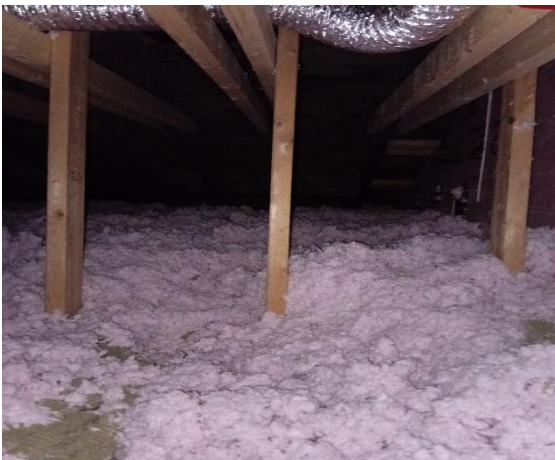
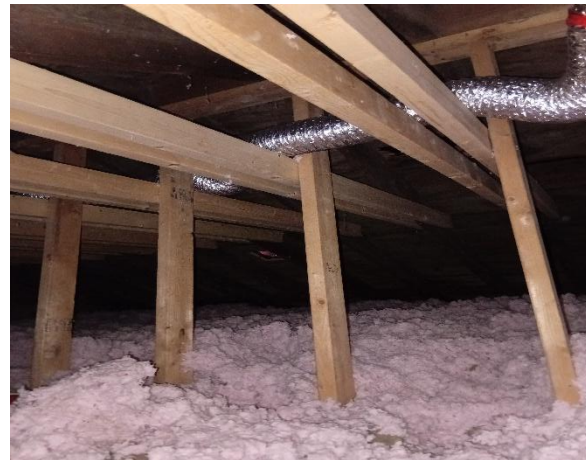
ATTIC (s).

Three distinct attic areas were accessed. The insulation, a combination of blown-in fiberglass and fiberglass batting is somewhat disturbed throughout but there was no evidence of condensation or mold. The ventilation appears adequate.

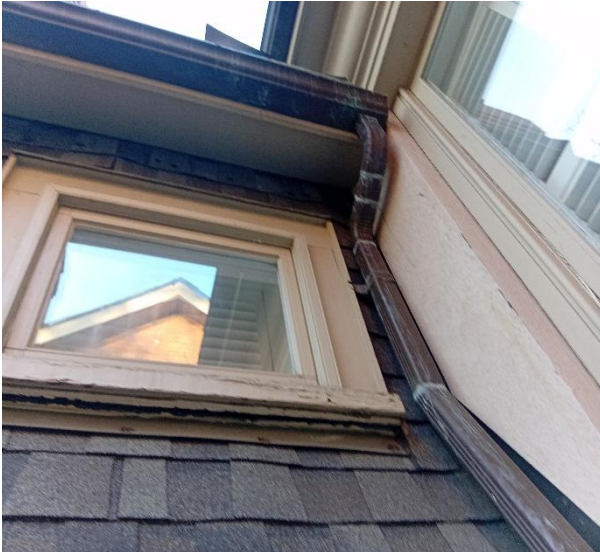
Upper downpipe discharges into lower causing overflow and damage to the wood details below.

Downpipe from upper roof.

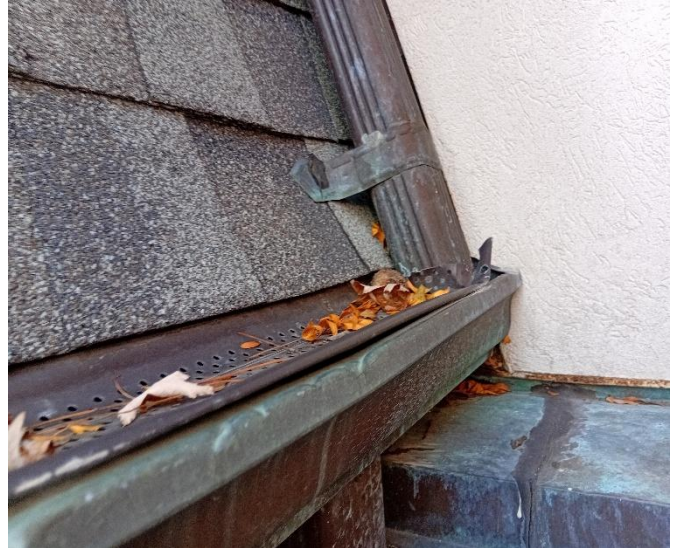
Discharge into lower eavestrough.

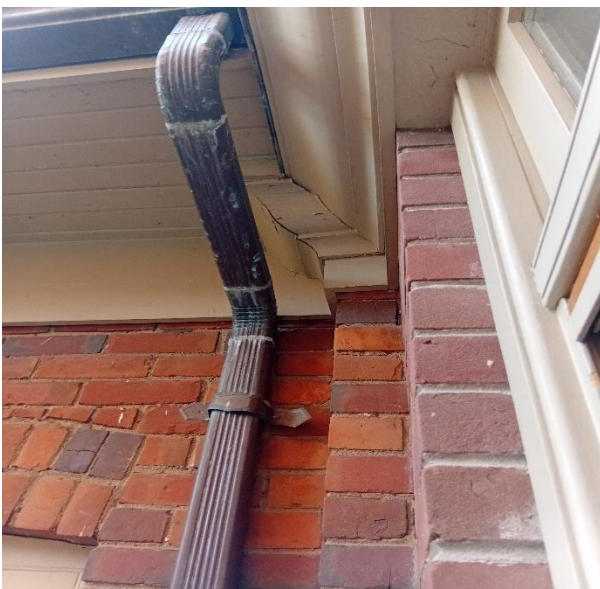
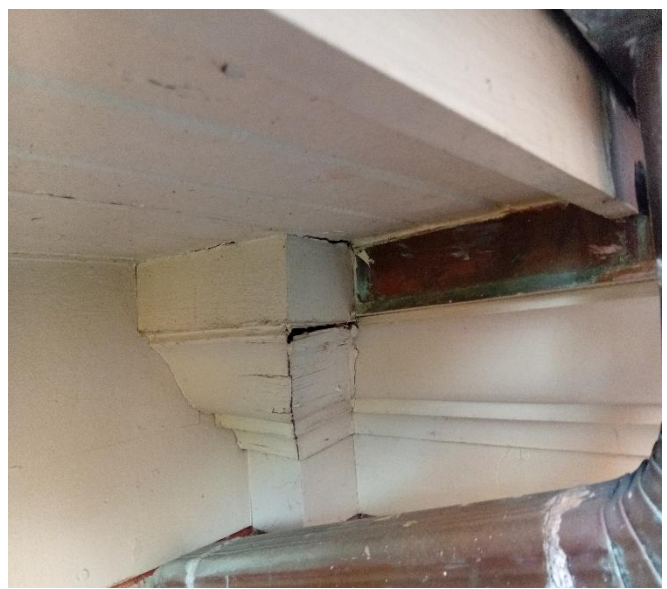
DAMAGE TO WOODWORK BELOW.
