## ROOF INSPECTION REPORT

INDIAN ROAD.  
TORONTO.

MARCH 31 2026

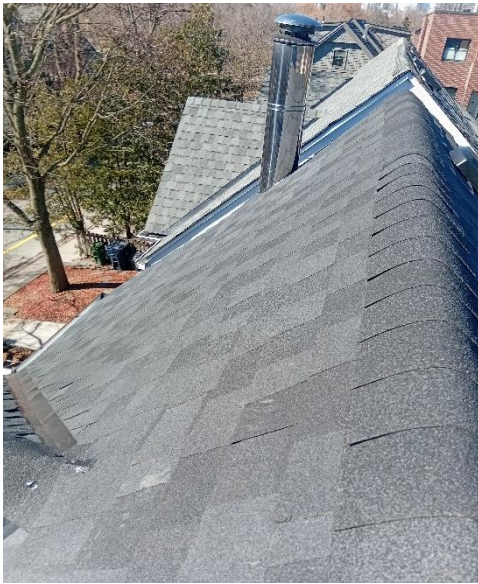
001

Image 001. Overview showing a heat stack.

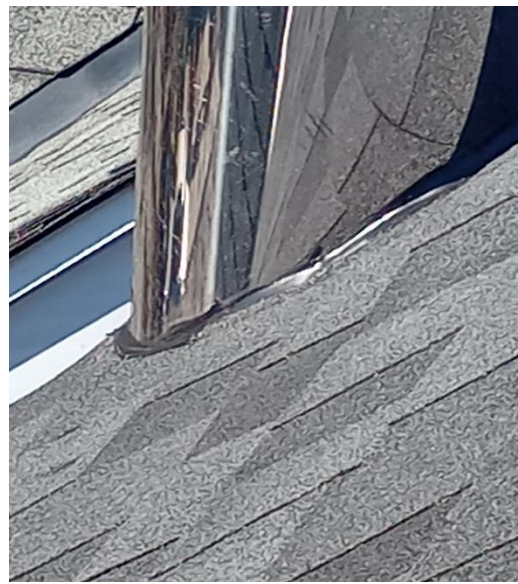
002

Image 002. Heat stack close-up. The stack is sealed at the shingles with caulking or a mastic product. Neither of these materials will survive over time. A heat stack must be sent through a 'cone and storm collar' fitting to isolate the stack from combustible materials such as shingles, as required by the Ontario Building Code.

Sound except for the lack of a 'cone and storm collar' fitting at the heat stack. Said fitting is a requirement.

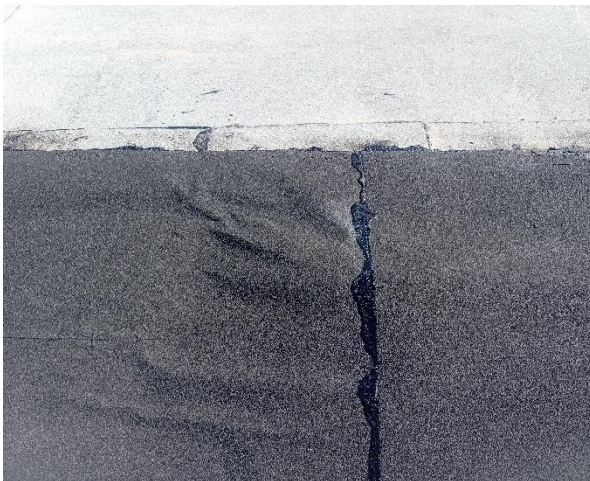
- 1) Images below. The membrane exhibits numerous wrinkles. These show that the membrane was not fully adhered to the substrate material and demonstrates sloppy workmanship by inexperienced labour. The images also show an excessive 'asphalt bleed' of 1" and up where a bleed of no more than ¼" is mandated. Excessive 'bleed' and a lack of embedded granules on the underlying membrane compromises the integrity of the seam. The lack of a bleed shows under heating. The seams' waterproofing ability is therefore compromised.

NOTE. Images 003 and 004 also show that the adjacent membrane had its' surface granules burnt and the granules not embedded prior to receiving the new membrane. The 'embedding' of granules of the substrate membrane is a requirement of the IKO membrane manufactures installation guide and standard roofing practice. This circumstance is common at all such details over the entire roof system.

This installation demonstrates poor workmanship by inexperienced installers, does not comply with the Manufacturers Installation guide nor the CRCA (Canadian Roofing Contractors Association) specifications for modified bitumen roof installation and standard roofing practice. It should be replaced.

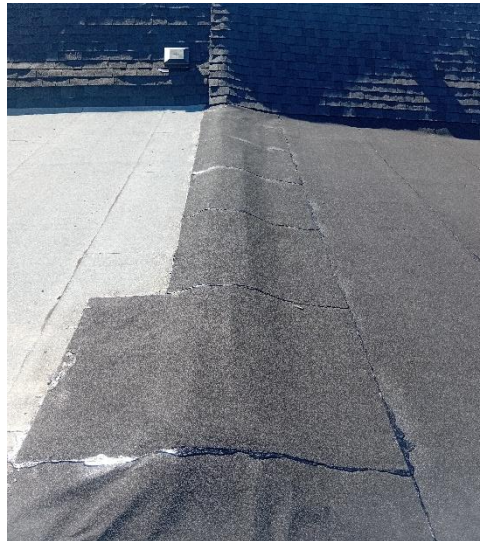
005

Wrinkles, excessive and or no bleed at all seams. The larger section of membrane is where the chimney was removed.

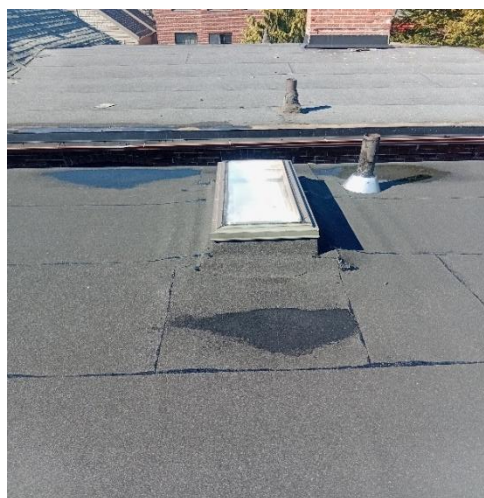
006

Image 006. The ponding of water shows that the substrate material was not effectively installed.
