## ROOF INSPECTION REPORT

INDIAN ROAD.  
TORONTO.

MARCH 31 2026

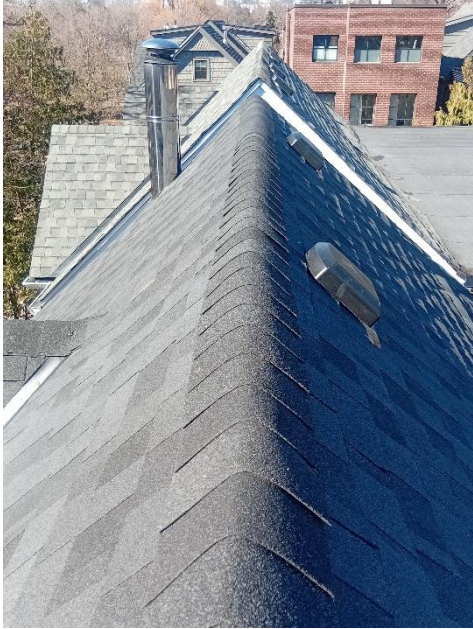
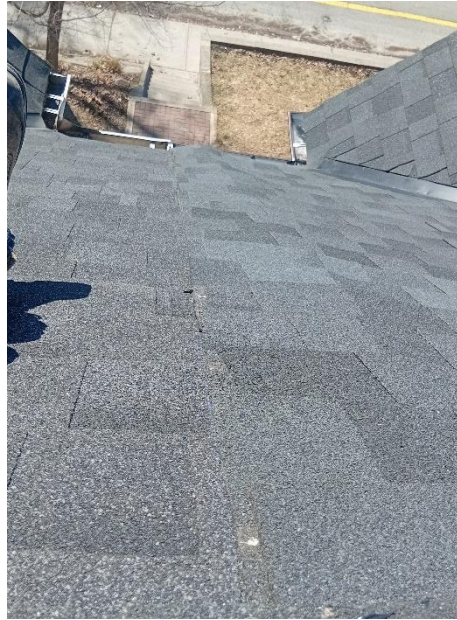
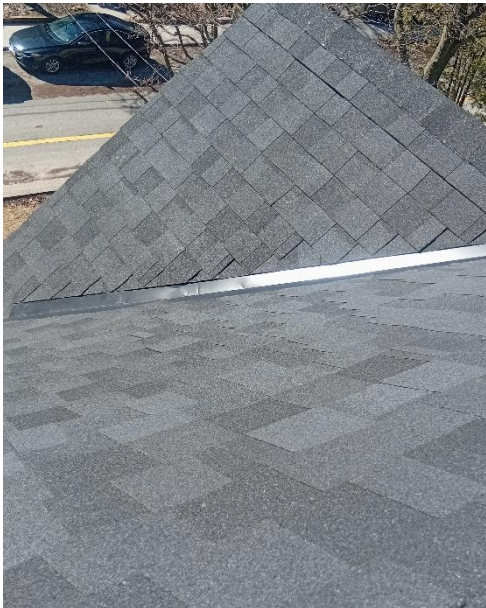
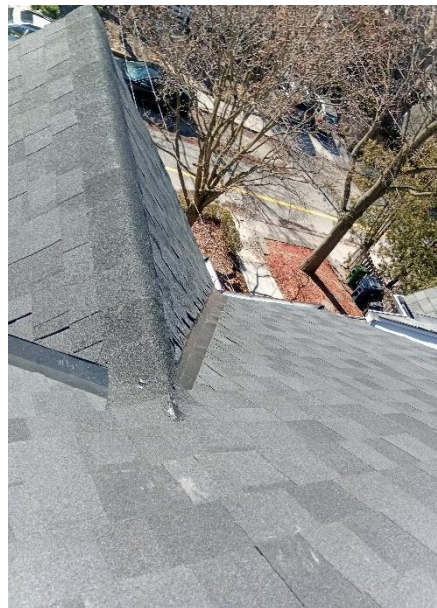
SHINGLE ROOF OVERVIEWS.

We are pleased to report that except for the deficiency listed herein the sloped roofing appears sound and should remain serviceable for the foreseeable future.

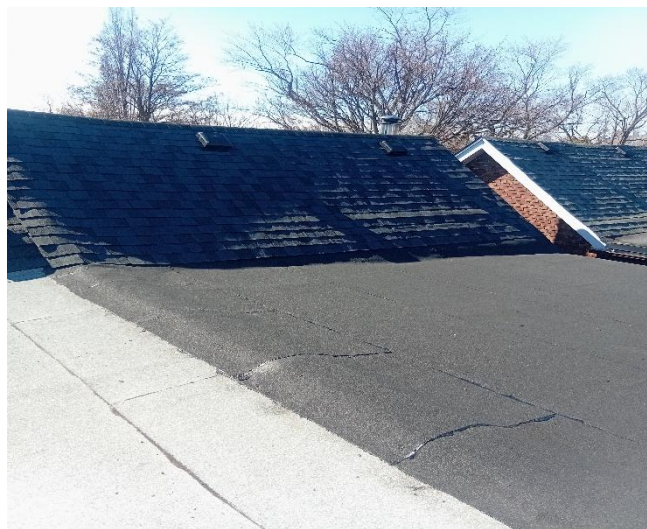
FLAT ROOF OVERVIEW and rear shingle slop.

The flat roof has numerous deficiencies.

This installation demonstrates poor workmanship by inexperienced installers, does not comply with the Manufacturers Installation guide nor the CRCA (Canadian Roofing Contractors Association) specifications for modified bitumen roof installation and standard roofing practice. It should be replaced.
